SEALING OF PERFORATIONS ON FLAT SURFACES

Roofs and facades

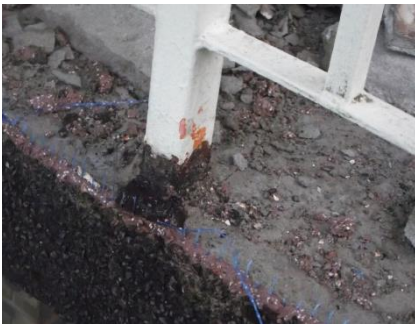
Image 4

The placement of permanent guardrails and perimeter guards at places of transit where maintenance activities are carried out or are used as a protective measure, cause medium and long-term problems in their connections to the surface. The wear of the base materials that are in contact with the substrate creates major problems of leakage into the construction.

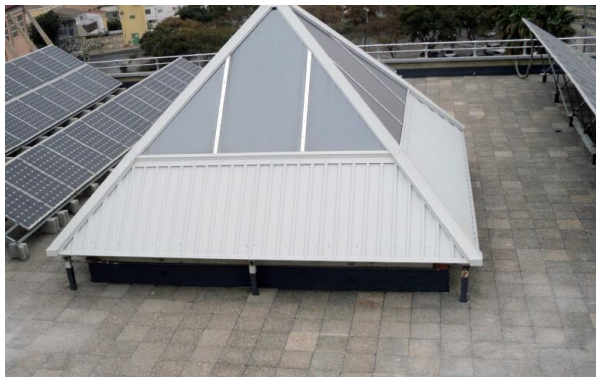
Image 7

The points at which a pipe or post passes through the surface from the inside to the outside space are crucial to carry out a proper sealing. At all these junctions if the waterproofing of the holes that are generated is not carried out from the beginning, the appearance of leaks is inevitable, causing major problems in the interior of the construction due to the fact that it isn't possible to ensure the watertightness in the holes.

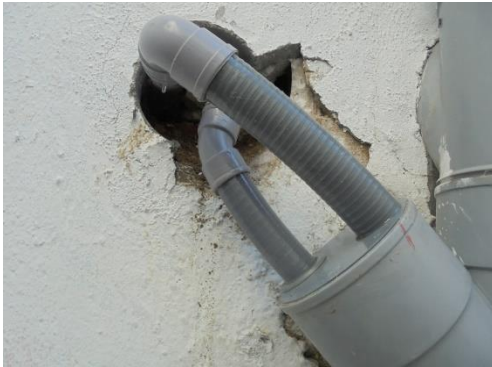
Image 9

Penetrations are not only found on horizontal surfaces. Along the facade there are numerous passages of cables and pipes. These parts are very complicated to waterproof due to their location, which causes errors in their applications that will result in problems of leaks in the encounters between surfaces, generating complications inside the building.

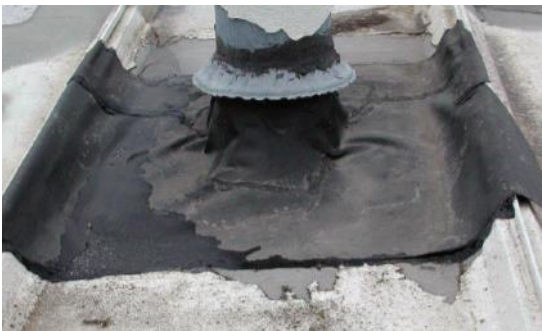
Image 11

Leakage problems occur when installations are carried out in an inappropriate or unprofessional manner. The most common applications are to use zinc sheet metal or galvanized sheet metal, sealants and other short-lived solutions. This can be a good solution, but when the wind and rain water begin to act strongly against the devices, it becomes a big problem due to the constant structural movements and thermal expansion. The equipment could not only bend or loosen at the base, but also cause cracks on the surface, resulting in material wear and premature failure.

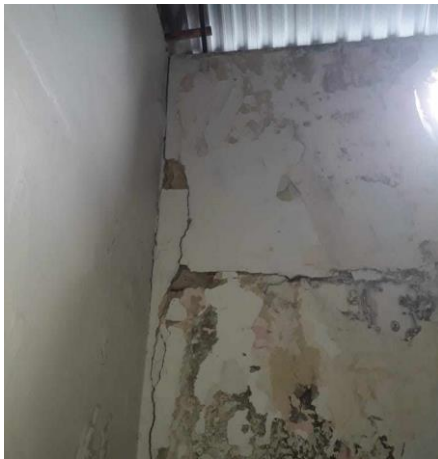
Image 13

When complications begin to appear on the outside of the building, they are then reflected on the inside of the building. The main consequences are:

- Fissures and cracks on the ceilings
- Humidity and condensation
- Mold and fungus
- Breakage of paint or plaster
- Shrinkage of materials

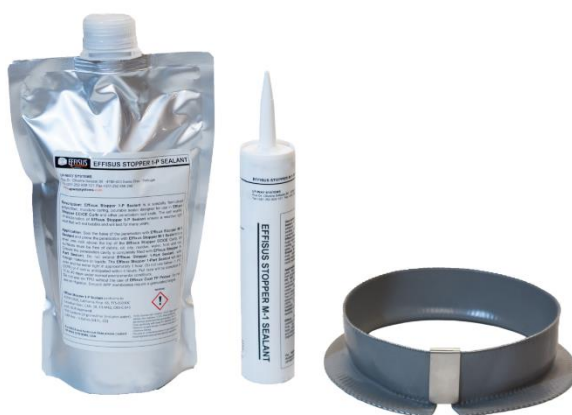
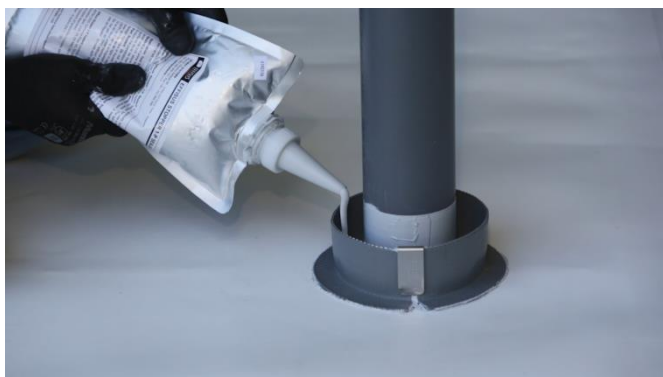
The Effisus Stopper system consists of three elements that are permanently flexible and adaptable to any situation and configuration on site. It is based on a mold, Effisus Multishapper, elastic and moldable made of polymer rubber with an internal reinforcement of aluminum; and on two sealants. On the one hand the sealant Effisus Stopper M-1 that allows the mold to adhere to any surface with total tightness and on the other hand the sealant Effisus Stopper 1-P that facilitates the filling of the mold in a self-leveling way with a permanent flexibility throughout its service life.

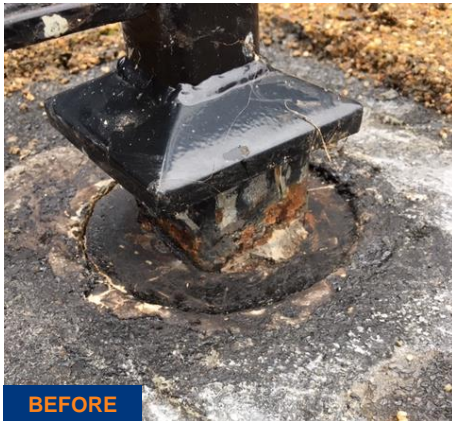
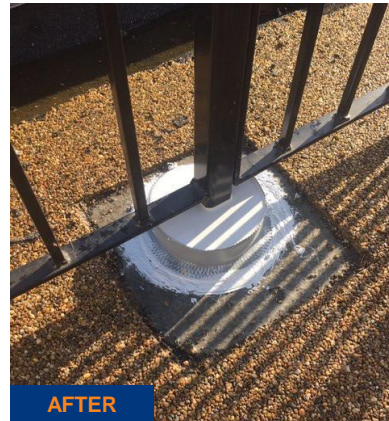
1) Sealing the base of a railing

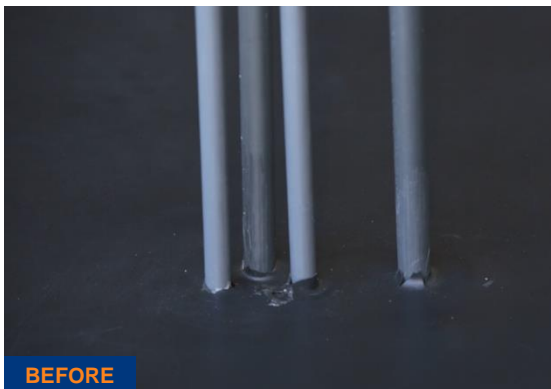
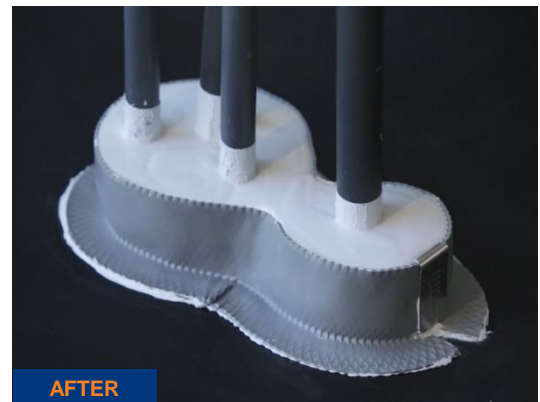
2) Sealing of multiple tubes through an EPDM membrane

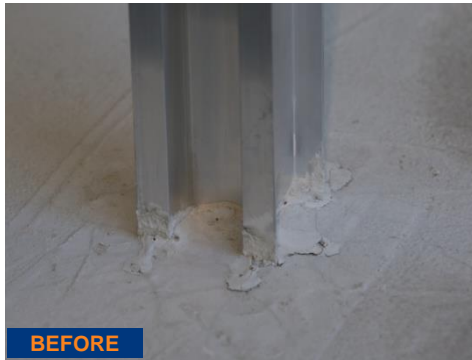
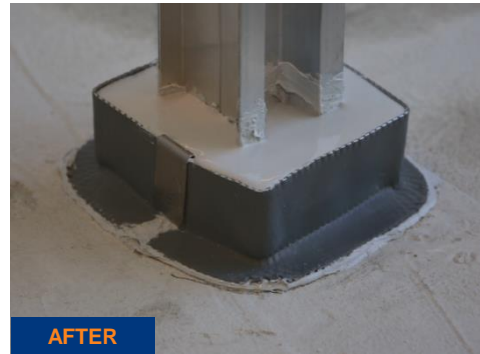
3) Waterproofing of a post on concrete surface

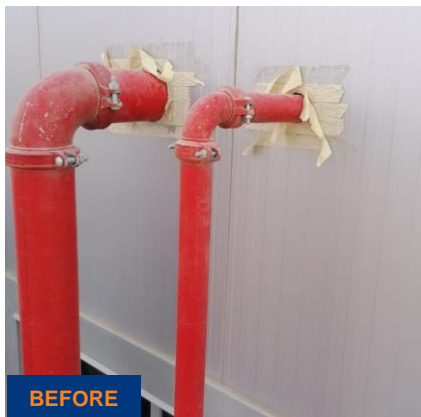
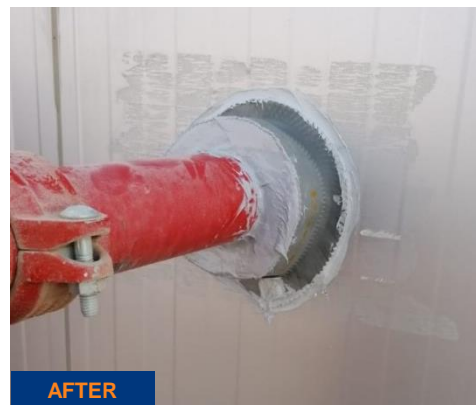
4) Waterproofing of a pipe through a facade
